# Benefits of European river restoration schemes

An analysis of 13 case studies aiming to integrate improvement of ecological conditions and flood risk mitigation

December 2017

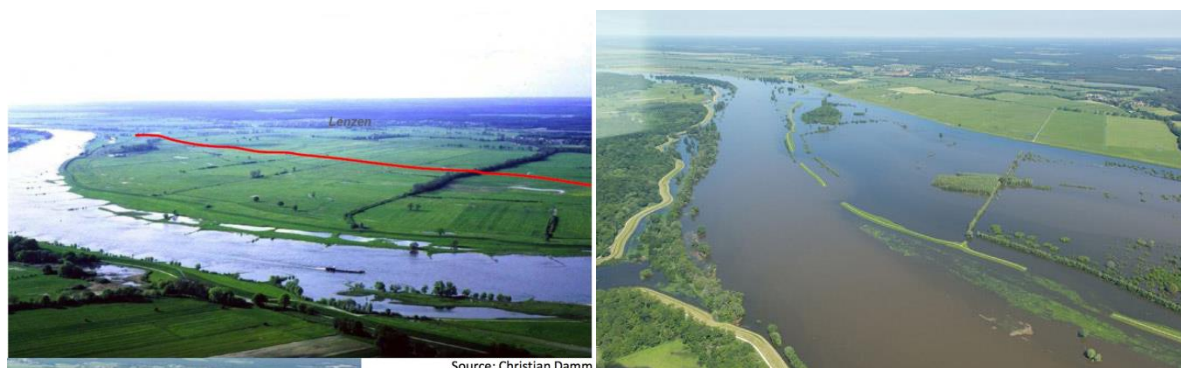
Figure 1. The area affected by the levee set-back: on the left, before the works; on the right, the openings shown at work during a flood. The red line on the left picture indicates the position of the new levee (sources, left: Christian Damm; right: Nora Künkler).

Several openings of 200-500 meters along the old levee were created, thus connecting the floodplain to the river in case of high flows, and a new levee was built 1.3 km further away from the river channel, to maintain control over larger floods. In addition, 160 ha of alluvial forest were planted and 85 ha of half-open pasture landscapes were established. In these areas, small stable ponds were also created. These measures required a land re-organization process in order to make areas available, as well as a new land-use practices, which was both promoted through compensation payments.

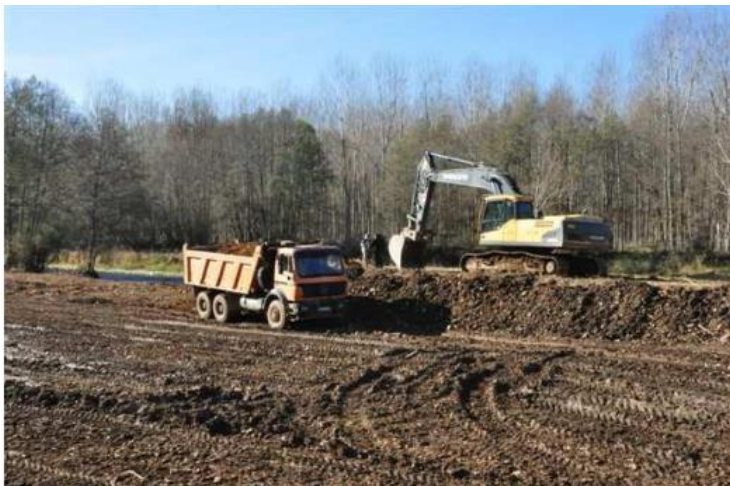
*Figure 3. An artificial levee is lowered to recover lateral connectivity.*

Rock armoring of river banks and earth embankments were removed from more than 13 kilometers of river channels. Some earth embankments were set-back along 5 kilometers of river channels, and other barriers such as groynes were lowered. 10 kilometers of secondary arms were reconnected and/or directly restored. Moreover, a riverbank vegetation buffer was created along 7.2 ha that were reconnected to the river. Other in-channel obstacles, namely weirs, were modified to restore continuity for fish fauna and sediments. The project approach was very different from the experience of the local stakeholders, who were initially reluctant, especially towards expropriation. However, active public participation was set in place, involving stakeholders in 50 meetings during 3 years and eventually facilitating a successful implementation.

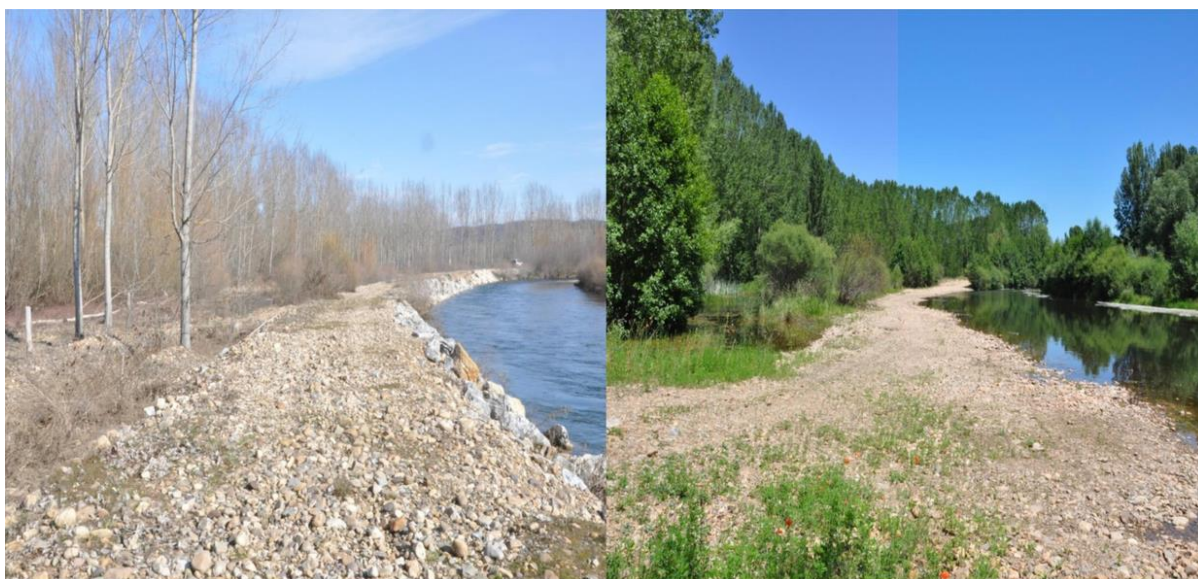
*Figure 4. River bank protections were also removed along the river: on the left, the situation before the project; on the right, the river is reconnected to its floodplain (source: Duero River Basin Authority – Confederación Hidrográfica del Duero, CHD).*

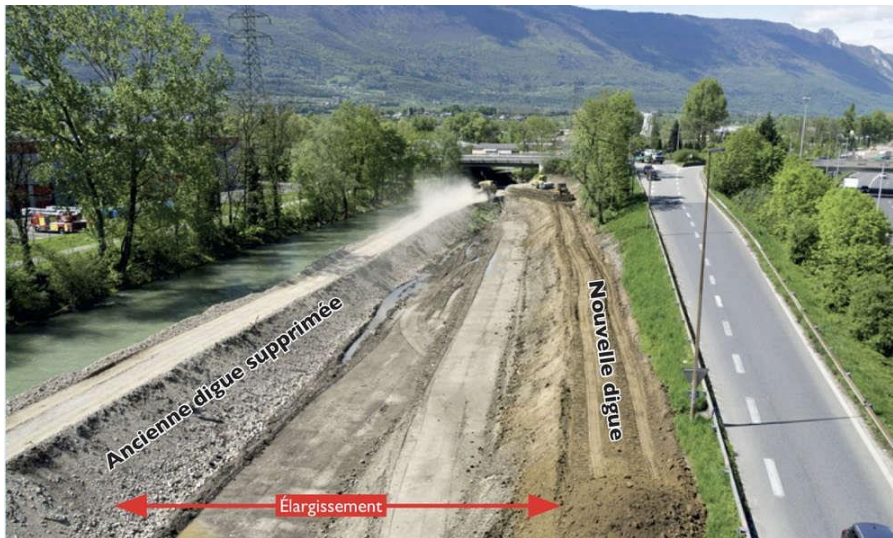
Figure 5. Construction works: setting back the levee.

Levees were set back to enlarge the riverbed, and to leave space to the morphological dynamics as well as to the 100-year return period flood. Habitat and vegetation diversification were fostered by inserting small wood obstacles to promote vegetation growth within the river channel. These measures improved the ecological conditions of the river, and improved touristic attractiveness.

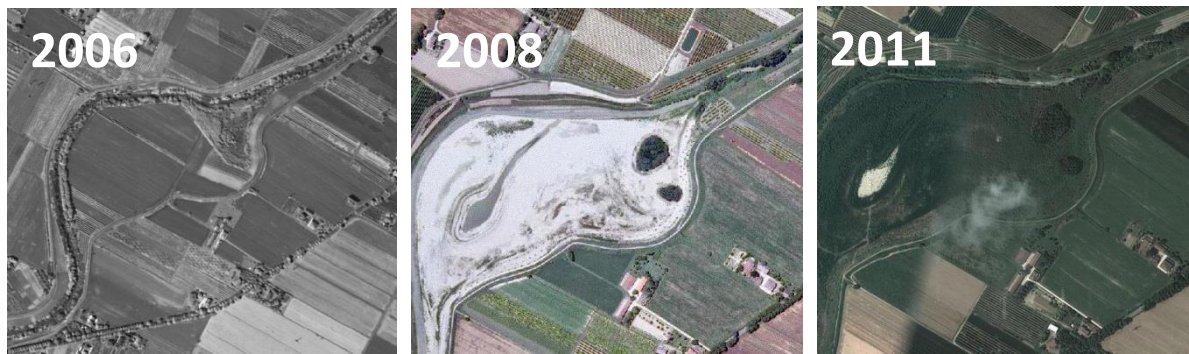
Figure 6. The terrace lowered in the project (source, Regione Emilia Romagna).

Within the restored reach the inner (i.e. secondary) embankments were removed and sixteen hectares of floodplain were lowered and reshaped. Fine material with no commercial interest was introduced in the channel during some ordinary flood events, in order to increase the sediment supply downstream and to ensure coastal replenishment.

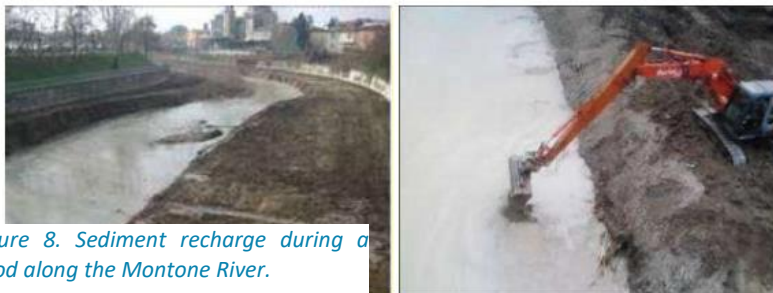
*Figure 8. Sediment recharge during a flood along the Montone River.*

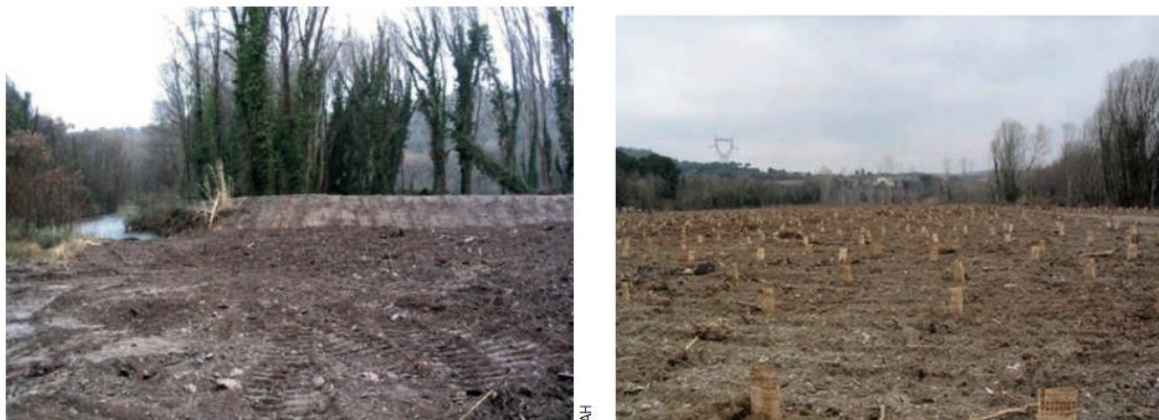
Figure 9. On the left, the newly constructed levee delineates the area. On the right, 5000 trees are planted in the area to decrease flow velocity during floods. Source: Syndicat intercommunal d'aménagement hydraulique des bassins de la Clamoux, de l'Orbiel et du Trapel (SBCOT)

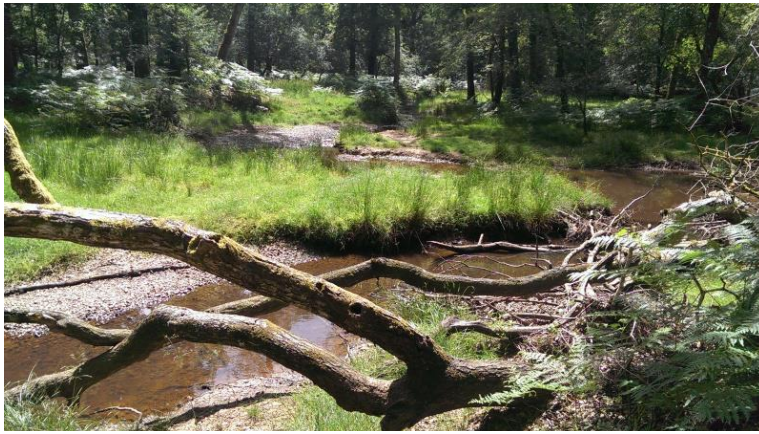
Figure 10. Large Woody Debris (LWD) are inserted in the channel (source, [https://restorerivers.eu/wiki/index.php?title=Case\\_study%3ANew\\_Forest\\_LIFE\\_project](https://restorerivers.eu/wiki/index.php?title=Case_study%3ANew_Forest_LIFE_project)).

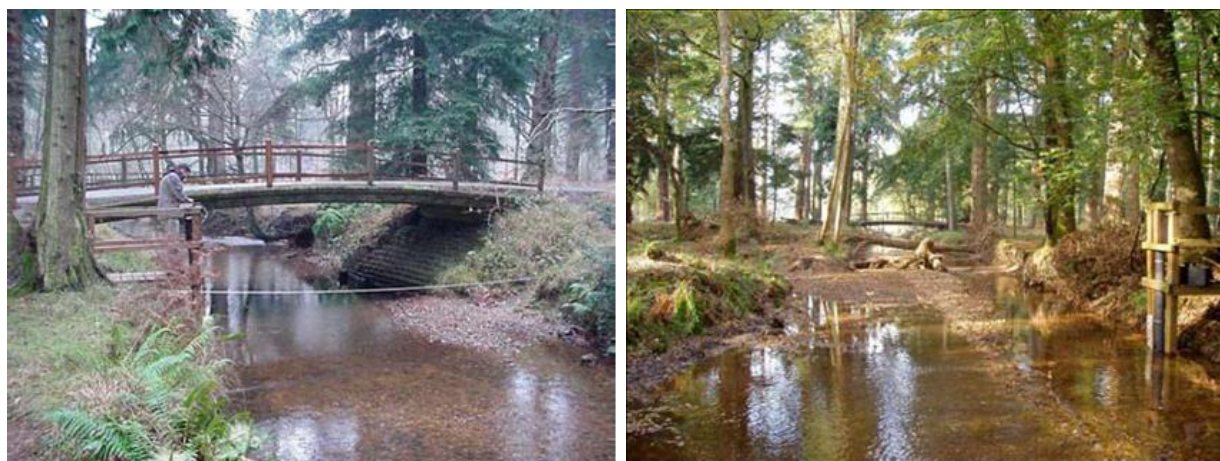
Figure 12. Blackwater River before (left) and after (right) the restoration actions (source, Hydrological Report of “Sustainable Wetland Restoration in the New Forest” LIFE 3 Project).

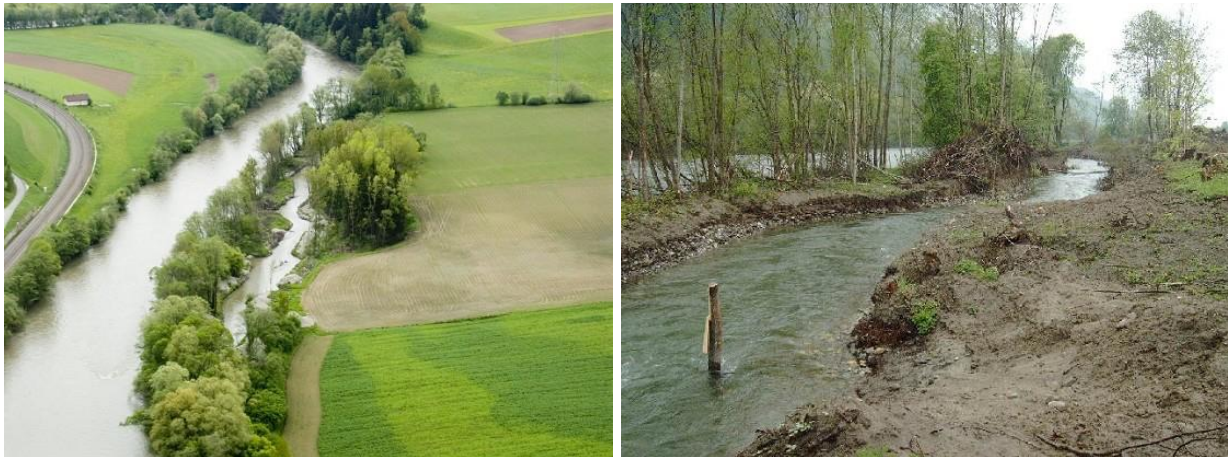
Figure 13. An abandoned channel is reshaped, and reconnected to the main channel at Thalheim. Source: Laymans report on “LIFE-UPPER MUR mur[er]leben 2003-2016”.

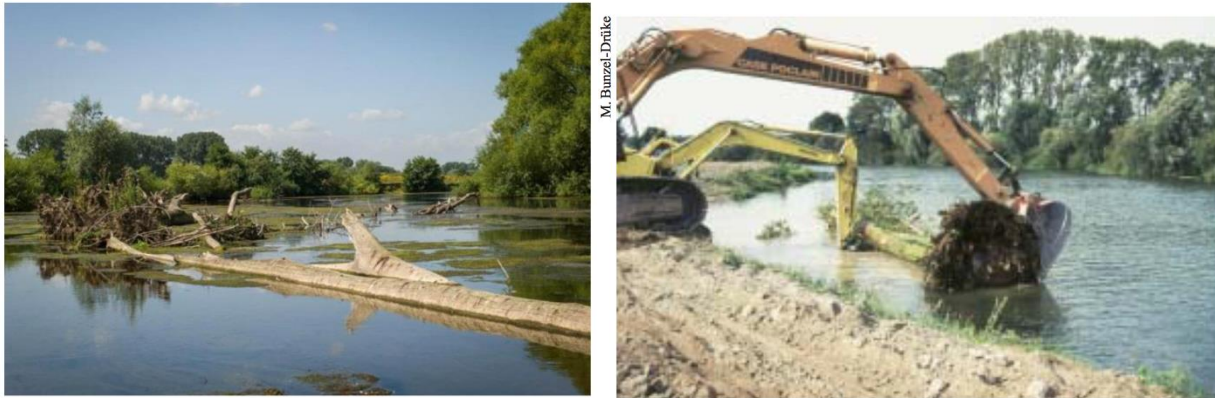
Figure 16. Large Woody Debris were put in place to initiate natural dynamics (source, M. Bunzel-Drücke).

the restored reach to prevent channel incision and several Large Woody Debris (LWD) were introduced in the main channel to initiate natural channel dynamics and to increase local depth variability. Bank protection and fixations were also removed, widening the active channel from 13 to 45 meters. Floodplain use was restricted to extensive grazing to allow for natural succession of floodplain vegetation.

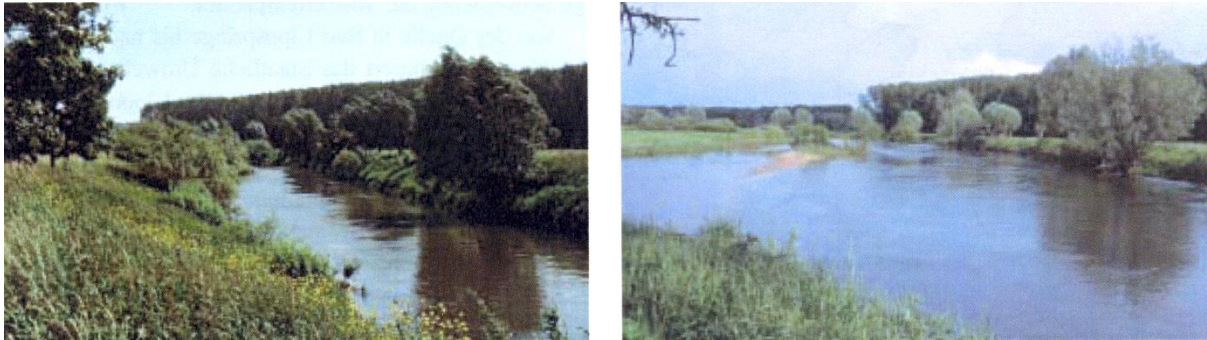
*Figure 18. Lippe River before (left) and after (right) the restoration actions (source, J. Drüke).*

In this intervention, sediments were directly added into the river channel, until it was raised by two meters, and therefore reconnected with its floodplain. A ramp was built at the downstream end of

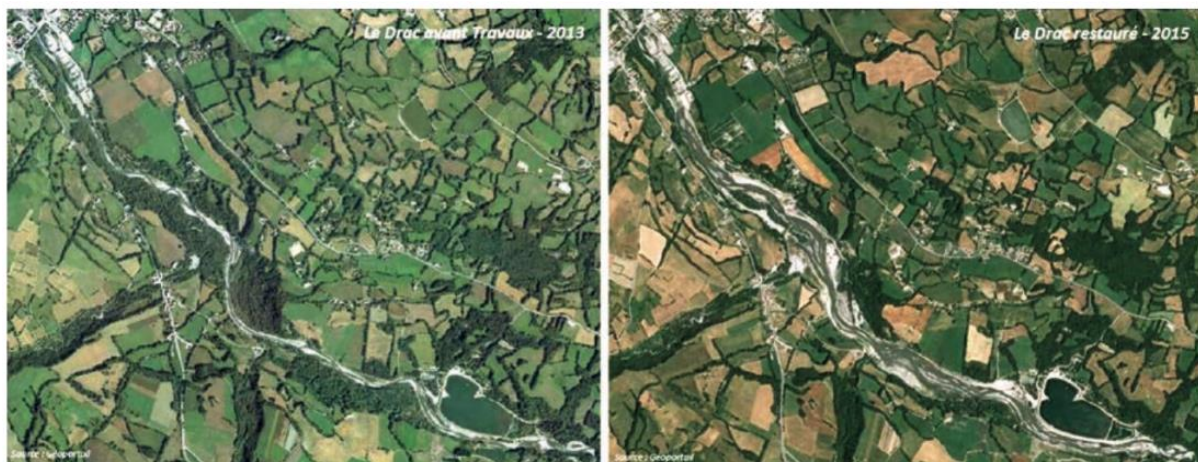
Figure 20. On the left panel, aerial view on the single channel Drac prior the 2013 intervention; the Champsaur dam can be recognized in the bottom right corner. The river flows towards the top of the picture. On the right panel, the same area is covered.

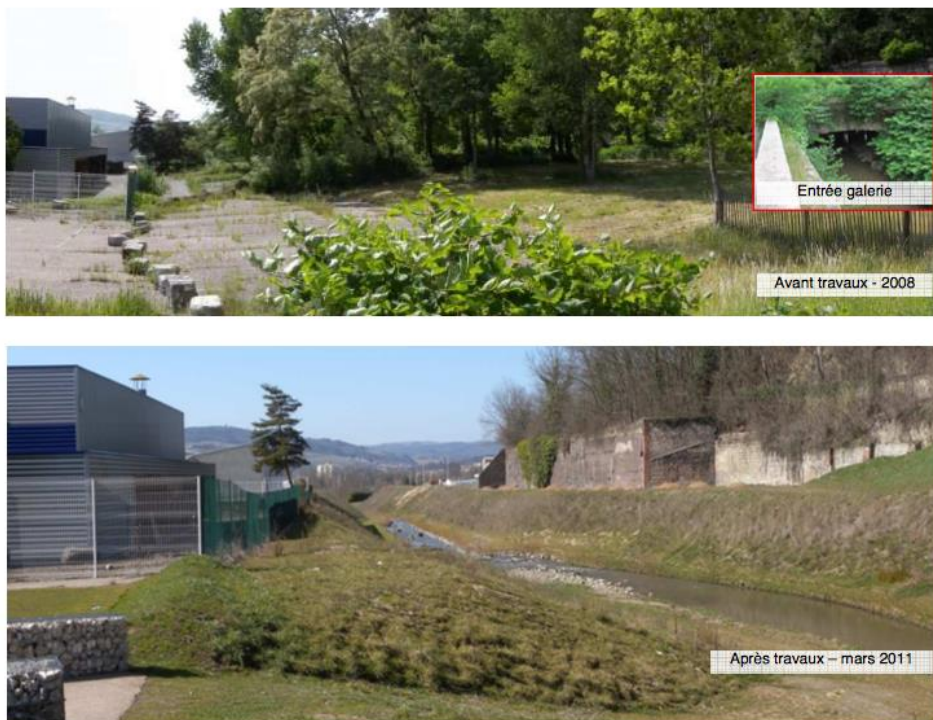
Figure 21. A view of the deculverting works: on top, the situation prior interventions; below, the reopened channel is pictured in 2011. Source: Saint'Etienne metropole.

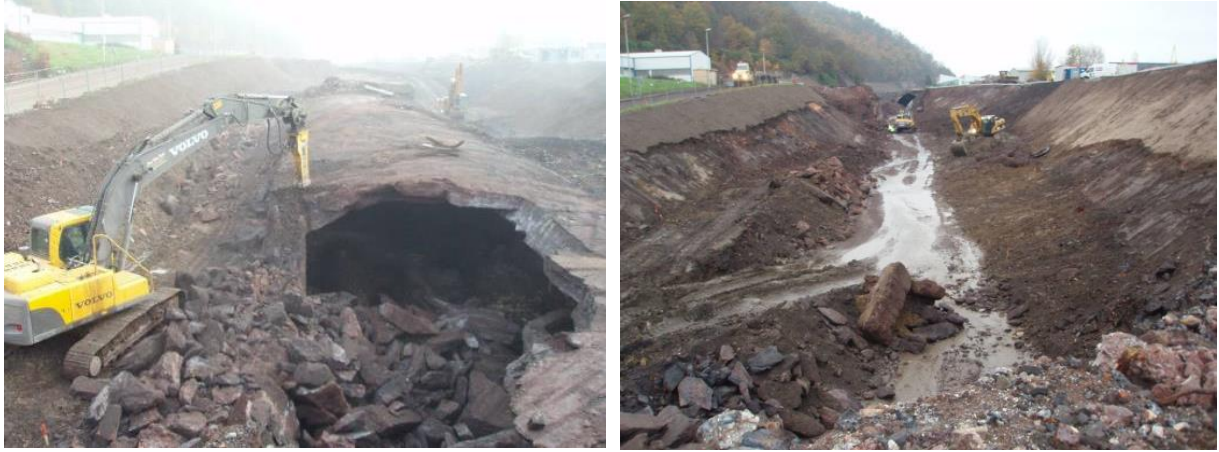
*Figure 22 The reopening works at the Ondaine river*

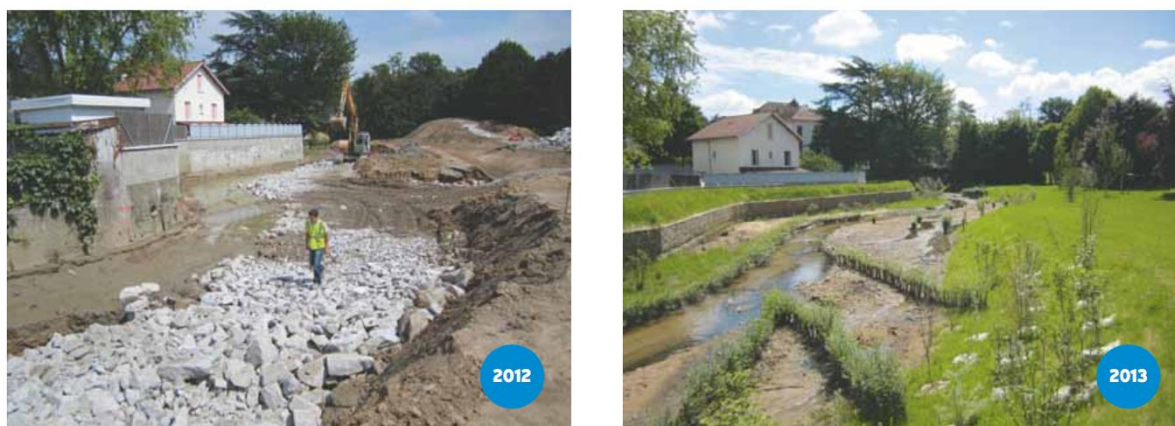
Figure 24. A section of the works completed on the Yzeron, at Charbonnières-les-Bains. Source: Sagyrc, Syndicat intercommunal du bassin de l'Yzeron.

Enlargement of the riverbed was combined to reshaping of the river aimed at increasing channel sinuosity. A footbridge to improve recreational opportunities was constructed to replace the two destroyed by the flood in 2008.

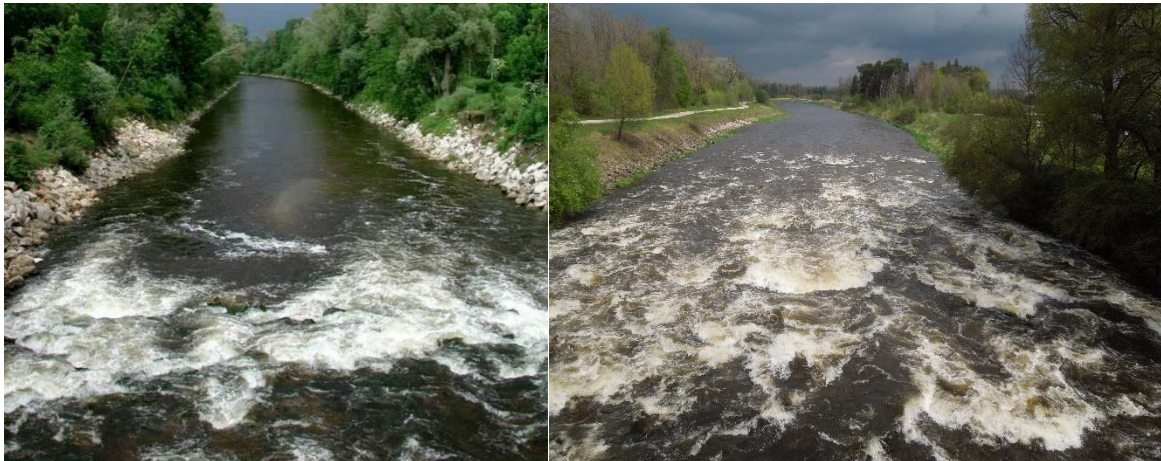
Figure 25. Wertach River from the Wertachbrücke before (left) and after (right) the restoration actions (sources, above: <http://www.wwa-don.bayern.de/hochwasser/hochwasserschutzprojekte/wertachvital/>; below, author: Dr. Martin Pusch, IGB).
