Five Case Studies on the Effects of the SWANCC and *Rapanos* Supreme Court Rulings on Colorado Wetlands and Streams

Author: Dennis Buechler
February 2010

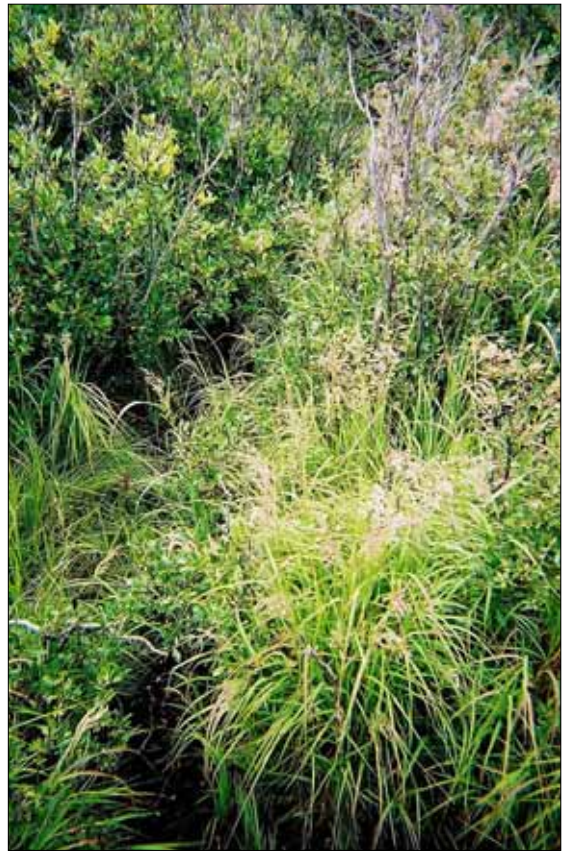
The soils were dark (note photo), peaty and highly saturated with standing water in some areas even though the terrain was sloped. It was so wet that no trees were sustained in that habitat. Note the thick lush growth of willows, sedges, and Canada reed grass in these photos, which were taken in mid-August. The average height of the willows was around 5 feet. While no detailed soil analysis was completed, it is quite likely that the Corps correctly identified this area as a fen wetland.

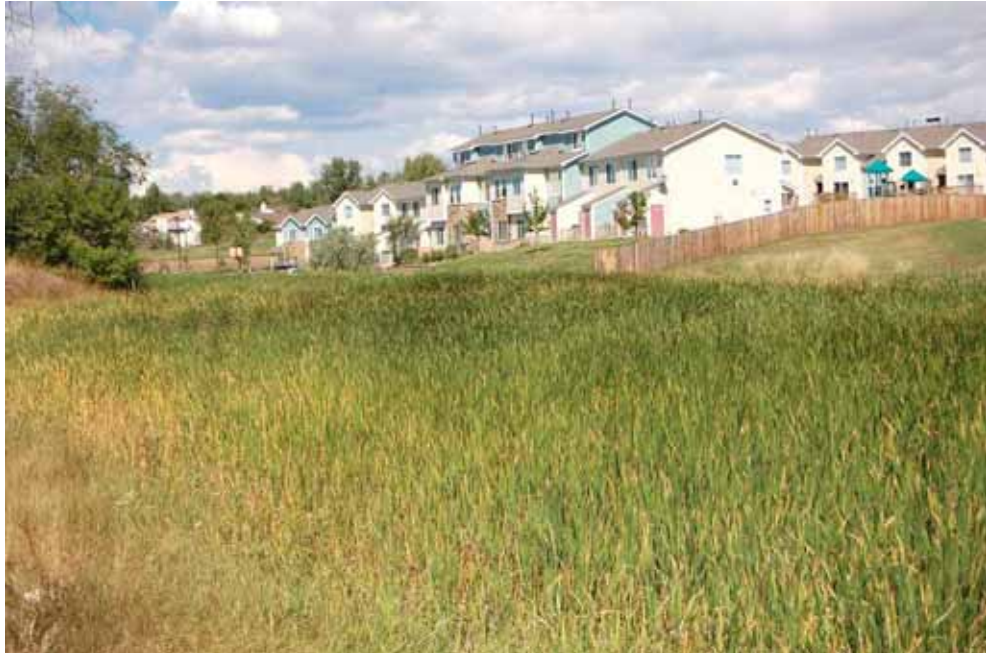
Picture on right: unnamed wetland drainage as it appeared in 2009.

In its determination, the Corps stated “This unnamed wetland drainage flows to Hidden Lake. Hidden Lake outlet goes underground. Hidden Lake is neither adjacent to nor surface connected to a waters of the U.S.” Therefore, the Corps decided this was a geographically isolated wetland and non-jurisdictional.

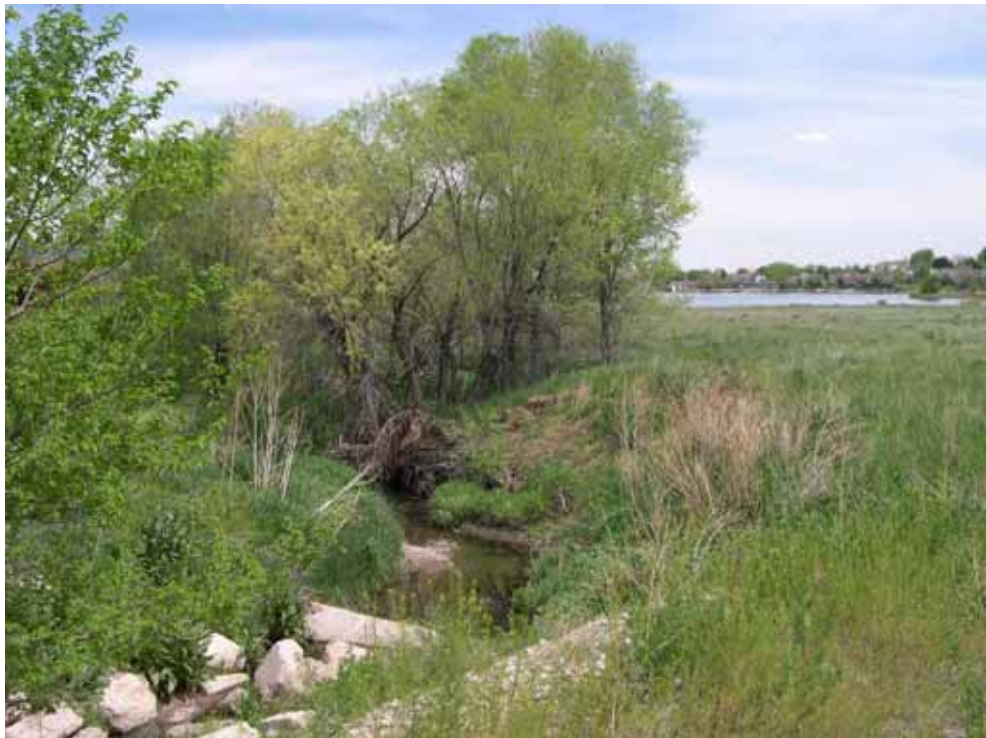
Picture on right shows flows from the wetlands in the above photo to the lake taken in May of 2005, but nothing was changed when observed in 2009.

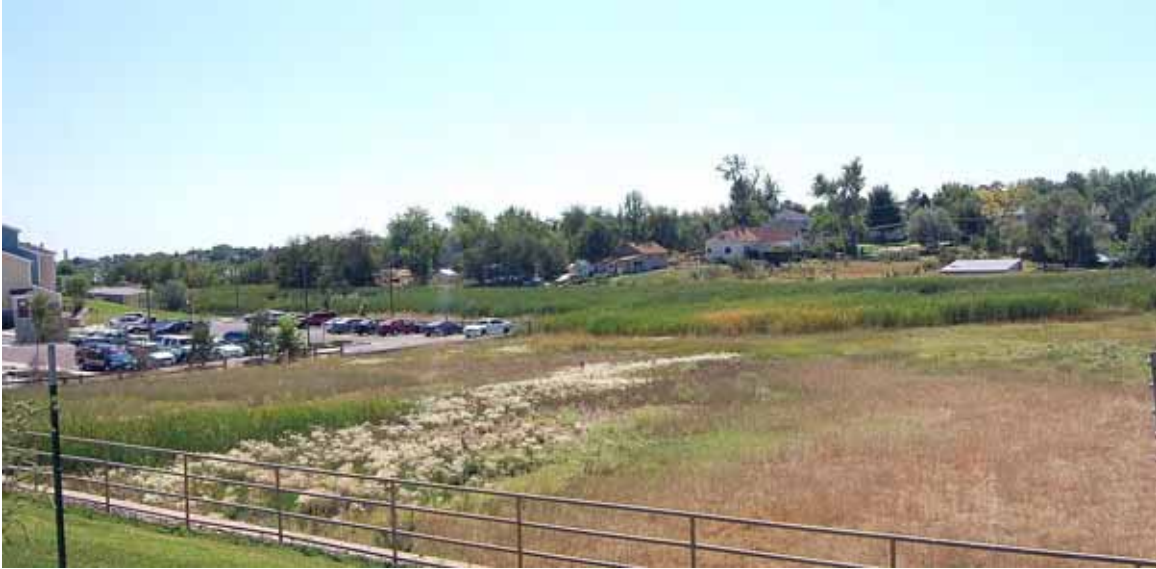
The author visited the site on September 7. Most of the wetlands that were present in 2005 were still there except for that portion that had been eliminated by construction of the lower parking lots (photo below). The dense cattails are important for absorbing nitrogen and phosphorus coming from residences with horse corrals that lie to the west and upslope in the drainage.

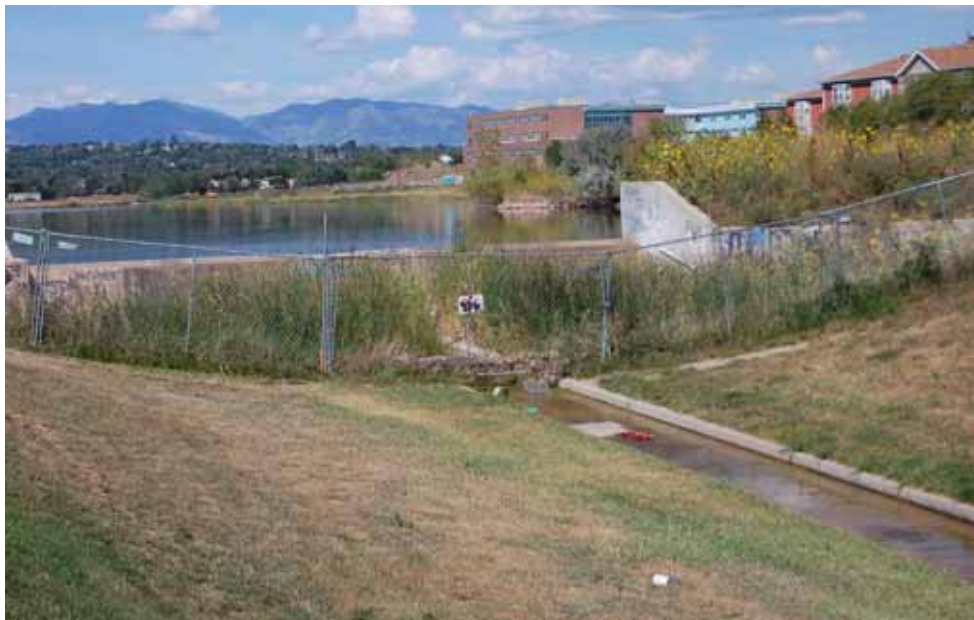
The author also inspected the spillway. The water was only a few inches below the top of the spillway, which seemed to confirm the statement by the City Engineer that overflows are not uncommon. Also, note the aquatic vegetation below the spillway overflow and the water that continues to leak into the channel. Therefore it can be assumed that a connection to Clear Creek still exists.

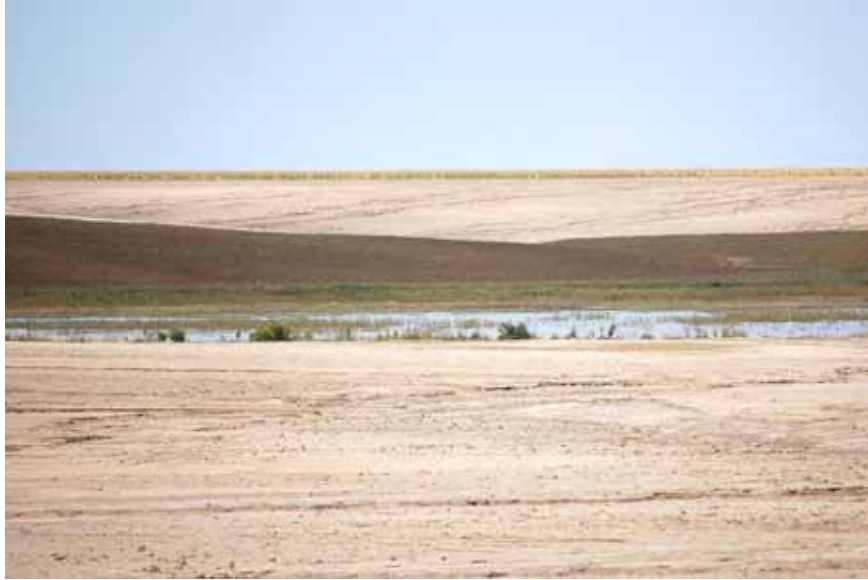
However, it was apparent that the USGS trench did not result in effective drainage of the playa. As the photo below demonstrates, it was vegetated and filled with water when the author visited the site. The photo was taken from the road shown on the bottom of the photo above.

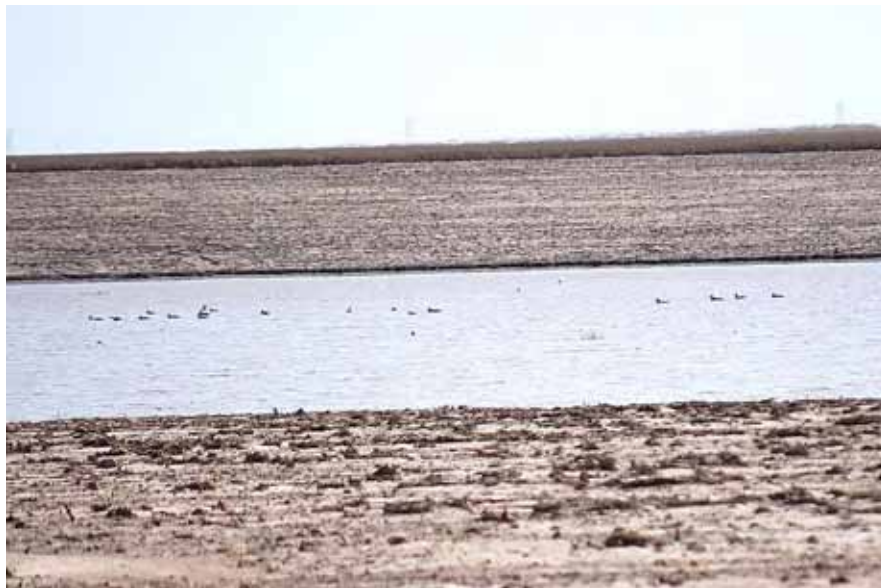
The photo below of a similar playa about ¼ mile south of the road demonstrates the value of these wetlands. When the subject site was visited by the author, it was being used by at least forty ducks, mostly blue-winged teal. It is also obvious in these photos that many of these playas are surrounded by intensely cultivated agriculture land. Therefore, they provide an oasis of habitat in the semi-arid plains. However, because they are usually geographically isolated, the Corps probably does not take jurisdiction over playas in most cases.

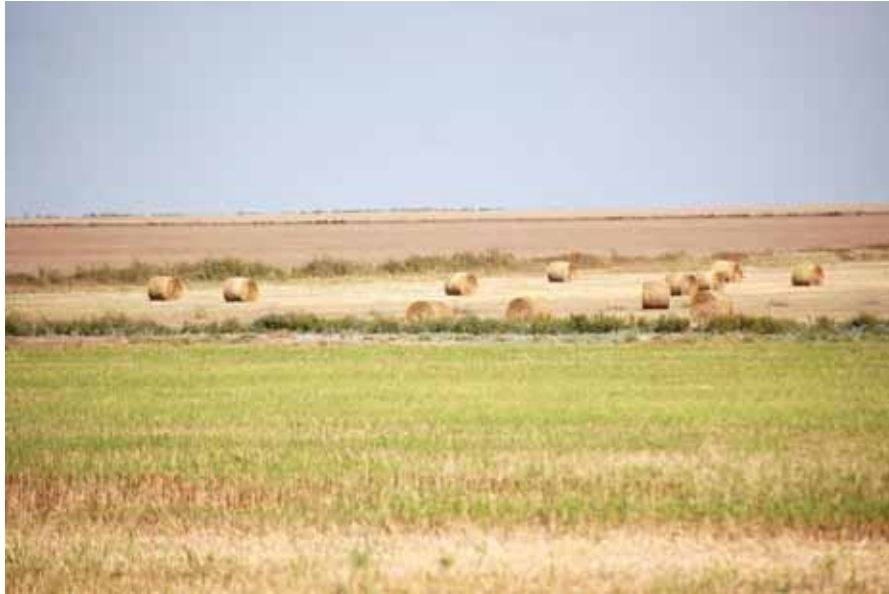
As can be seen in the following photo, some playas also provide hay and forage benefits to farmers and ranchers in the area. The landowner was able to harvest several large bales of hay from this playa.

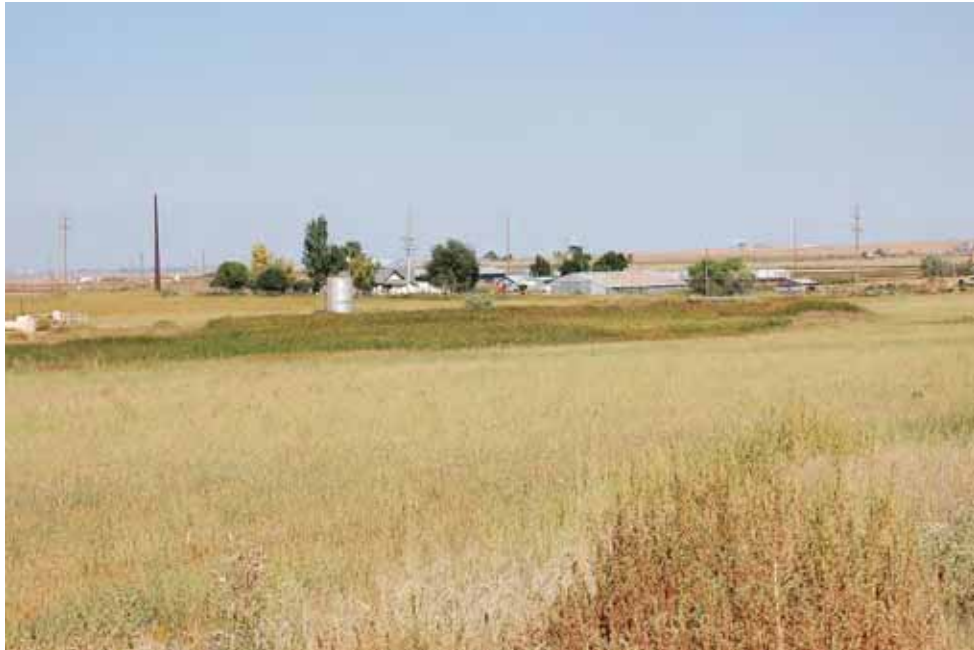
The site visit verified that Wetland A appears to be a high quality, fully functional wetland that drains into Little Dry Creek.

Wetlands A and B are separated by a low-level dam, which is located in the small light green trees shown just to the right of the oil tank in the photo above and in the center of the photo on the next page. This dam bisects what historically was a string of wetlands stretching for about 1/2 mile upslope from wetland A and appeared to have served as a means of crossing the drainage during wet periods. Some ponding probably occurs intermittently in Wetland B, which the Corps estimated to be 0.26 acre, but there did not appear to be any ponding during the site visit. Furthermore the only cattails were those immediately adjacent to the dam so the actual wetland acreage appeared to be much less than the acreage estimated by the Corps.

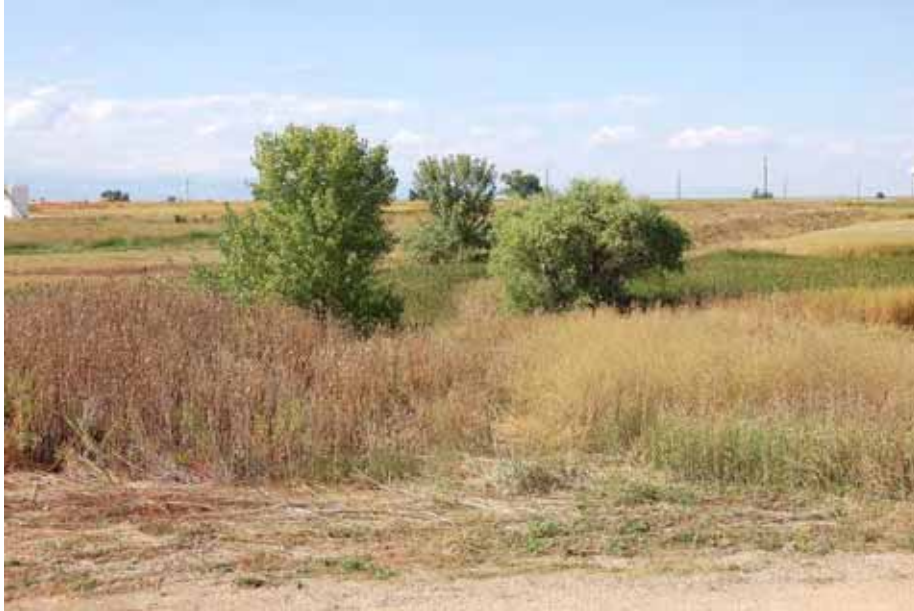
In the photo above, Wetland A is to the right of the trees, the small dam is the light colored vegetation in the center of the two nearest trees, and Wetland B is adjacent and to the left of the dam. Wetland C in the photo below is linear and quite small. It was estimated by the Corp to be 0.06 acre. It looked healthy, however, and thus provides wildlife habitat. As indicated by the Corps, it probably is dependent on flows from wetland D that travel through a culvert underneath Bull Canal (see Corps site photo).

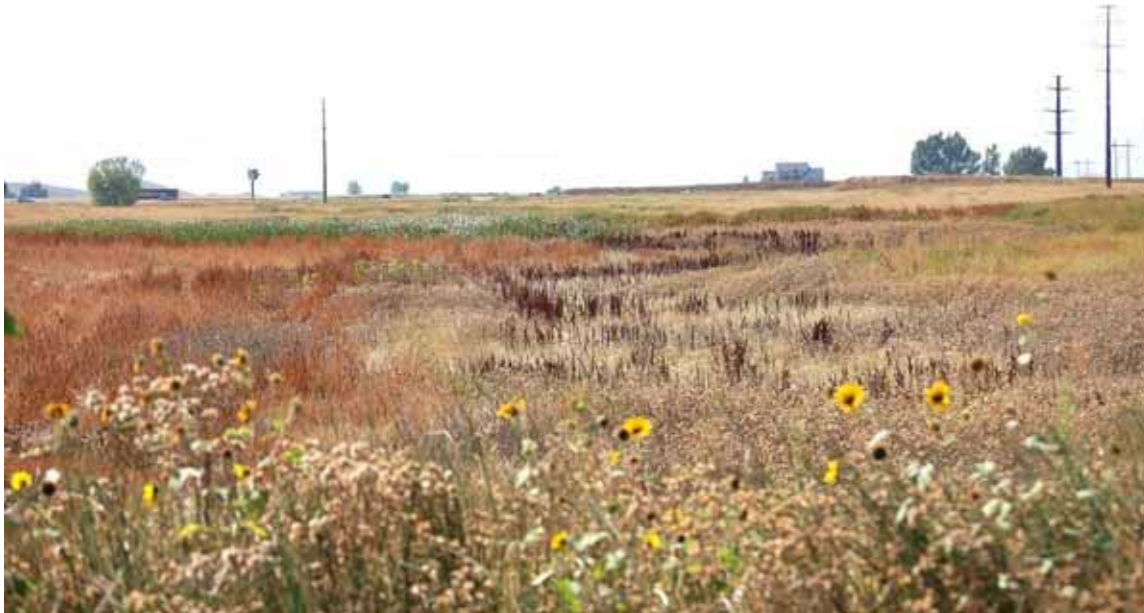
The basis for the Corps estimate of the size of Wetland D (see photo on next page) is unclear. There appeared to be a string of interconnected wetlands stretching upslope from the canal with a total acreage of much more than the 0.31-acre listed by the Corps. For example, the area in the center, which drains to the northeast from the cattails toward Wetland C, appeared to the author to be temporary wetlands not upland as

labeled in the Corps site photo. The dark plants in the middle of the photo are veiny dock (*Rumex venosus*), which is a hydrophytic plant. Therefore, without other data such as soils reports and vegetation sampling, the author concluded that the acreage estimate was only based upon the cattails.

Wetland D and the other adjacent upslope wetlands also appeared to be functional and to provide good quality habitat for migratory birds, small mammals, and perhaps fawning deer. While their water quality functions probably no longer provide benefits to Little Dry Creek, they likely have retained other wetland functions with regard to ground water recharge and retention of flood flows during precipitation events.

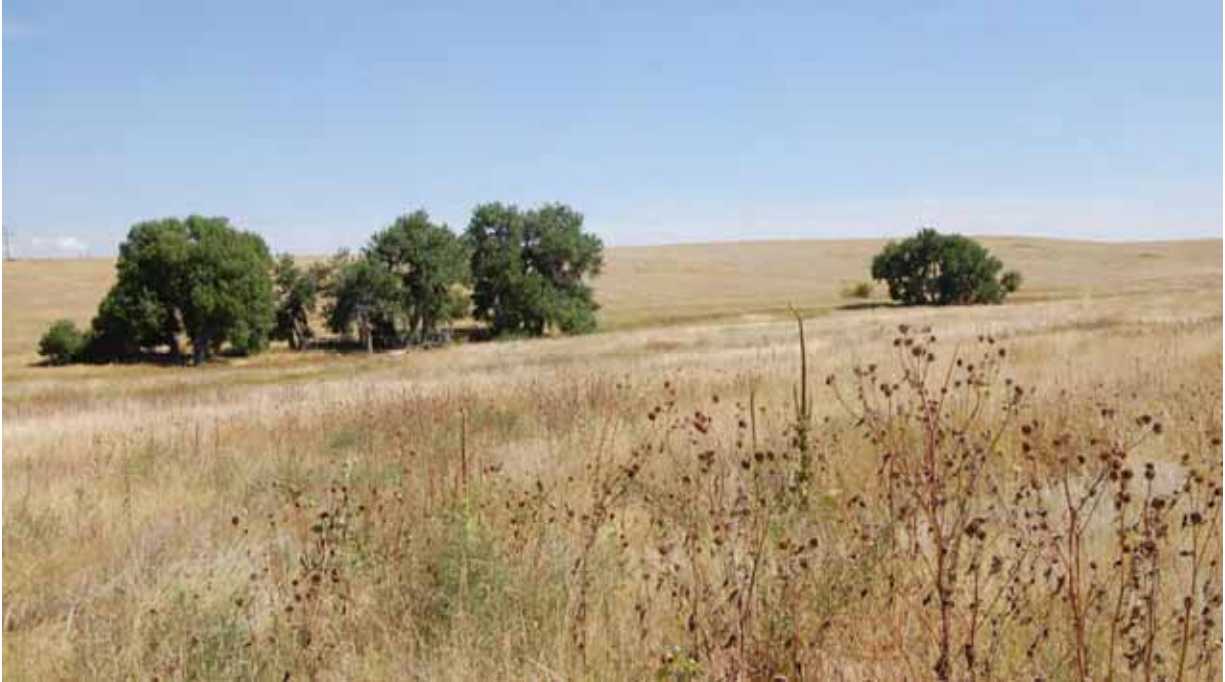
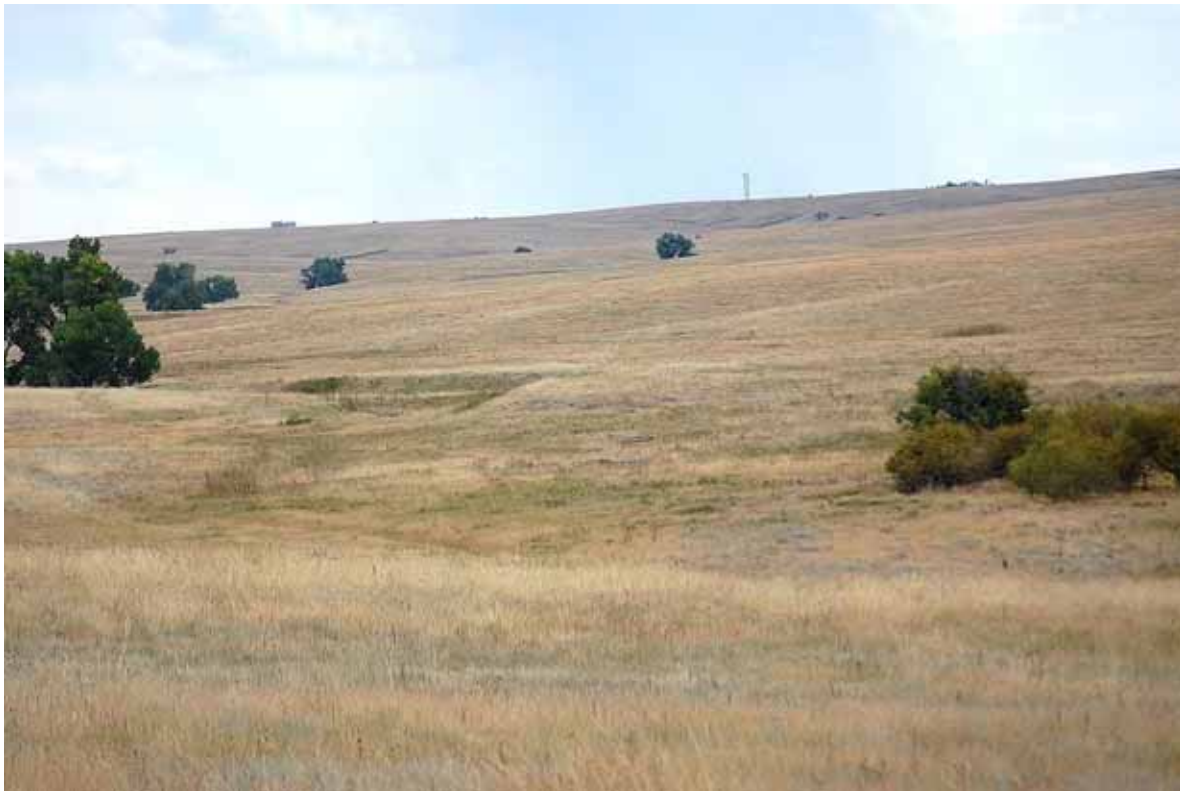
The first photo below is the approximate downstream end of the project (note color of grasses by the trees). The second photo is further down slope and about a half mile upstream from Coal Creek.

Whenever flows do reach Coal Creek, it is via the grassed waterway, which can be readily seen as the curved greener section in the middle of the above photo. Unless they otherwise demonstrate wetland characteristics or demonstrate characteristics of a tributary, grassed waterways have historically not been regulated as “waters of the United States” under the Clean Water Act. However, they often serve as important links between protected waters and demonstrate connectivity between such waters.

The grassed waterway shown in the above photo likely would not be delineated as a wetland under the Corps 1987 manual even though the tree layer is dominated by smooth-barked and plains cottonwoods. However, from a hydrological and biological standpoint, the presence of this grassed waterway combined with the tree species demonstrates a strong potential linkage between upstream waters and downstream waters. Those tree species are common in the eastern plains and are classified as hydrophytic (i.e., water loving) plants. They are typically found along streams and ephemeral waterways that have relatively high water tables and/or are frequently flooded.

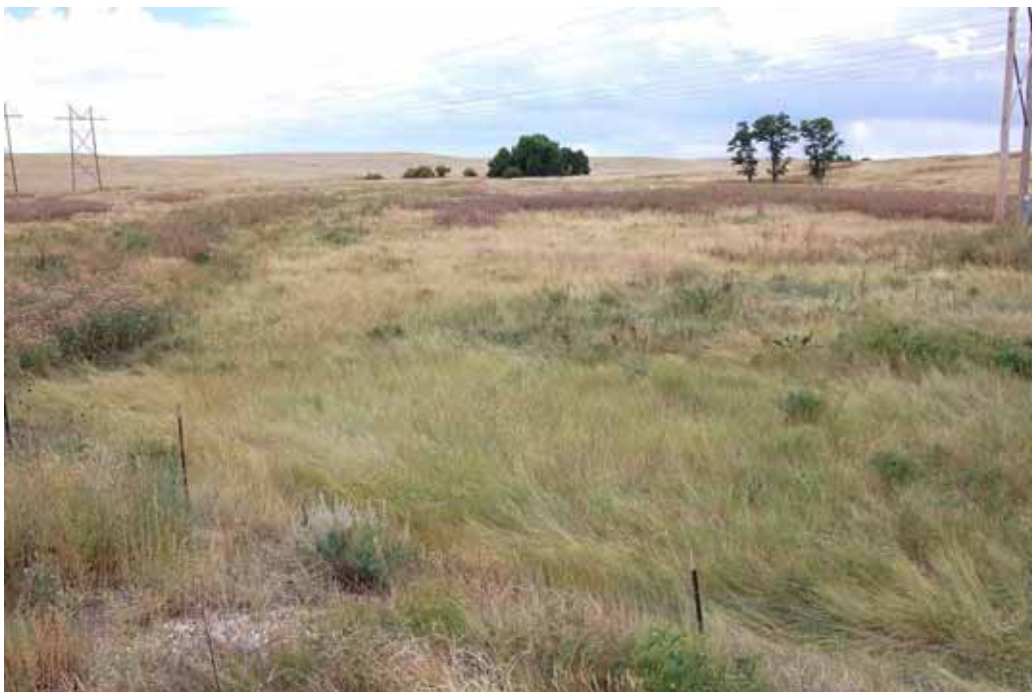
Notice the flattened grass in the below photo shot SE and next to the bridge on Quincy Avenue, which is 3.7 miles east of the junction of this road and Gun Club Road. The grass also is light green, more slender than on healthy western wheat grass, and has not headed out, despite the fact this picture was taken on September 14, 2009. Western wheat grass can normally tolerate short periods of inundation and saturation. Therefore, the stressed growth and flattened shape indicates a substantial amount of water runs through this drainage intermittently. Many of the plant species that can be seen upstream from the grassy area are common at sites influenced by water. They are significantly different than the native prairie grasses that border the drain.

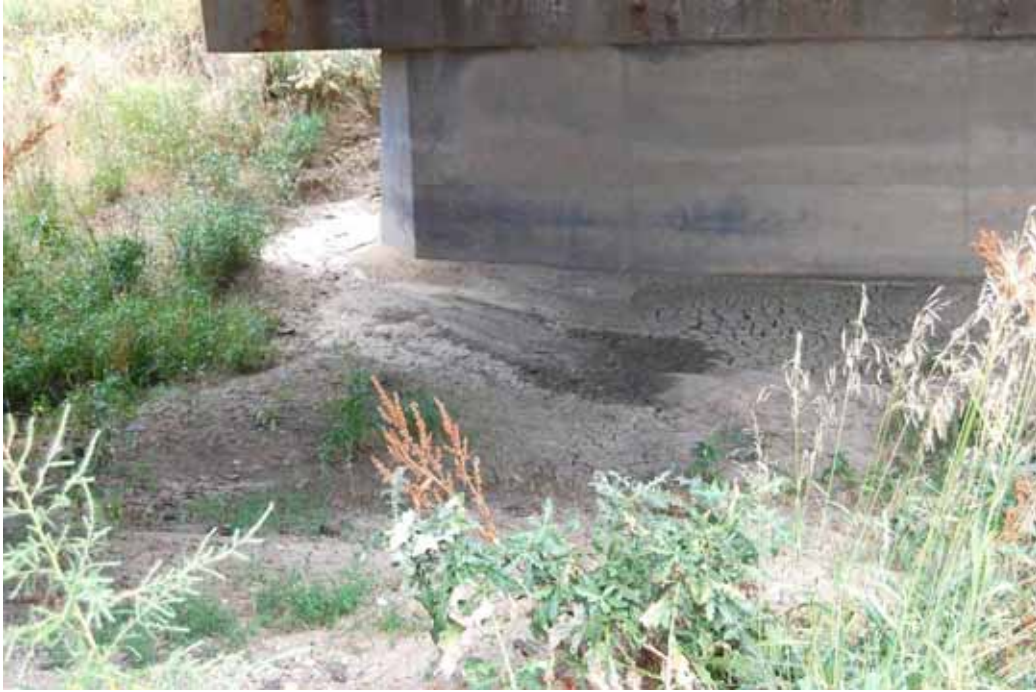
Recent high flow activity also was reflected in the area under the bridge because it was highly scoured and muddy on September 14, 2009 (see photo on next page).

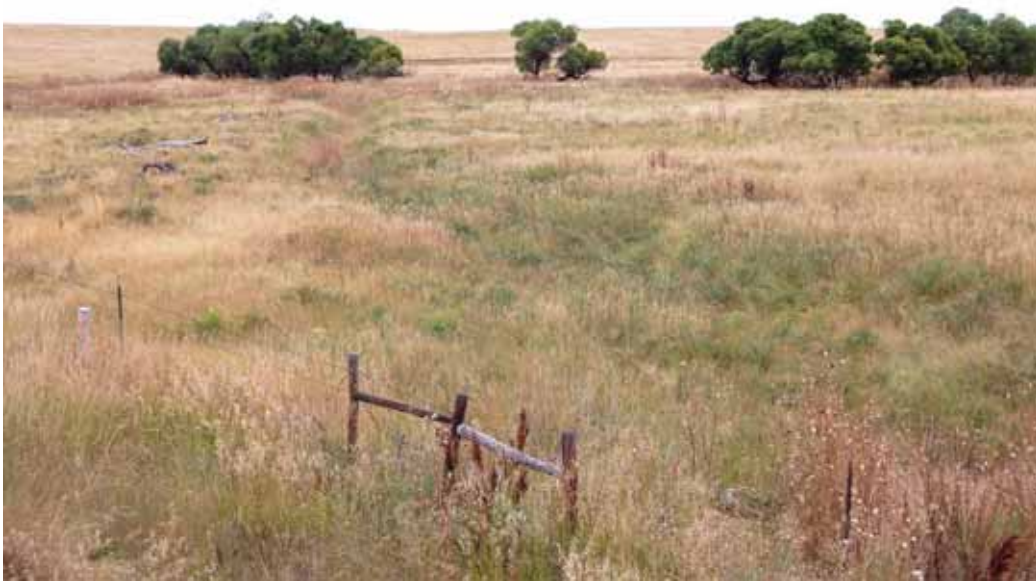
The following photo was shot NW from the bridge. At the tree line, the waterway turns right (north) toward the junction with Coal Creek. Note the defined waterway and how green the vegetation is compared to the surrounding area.

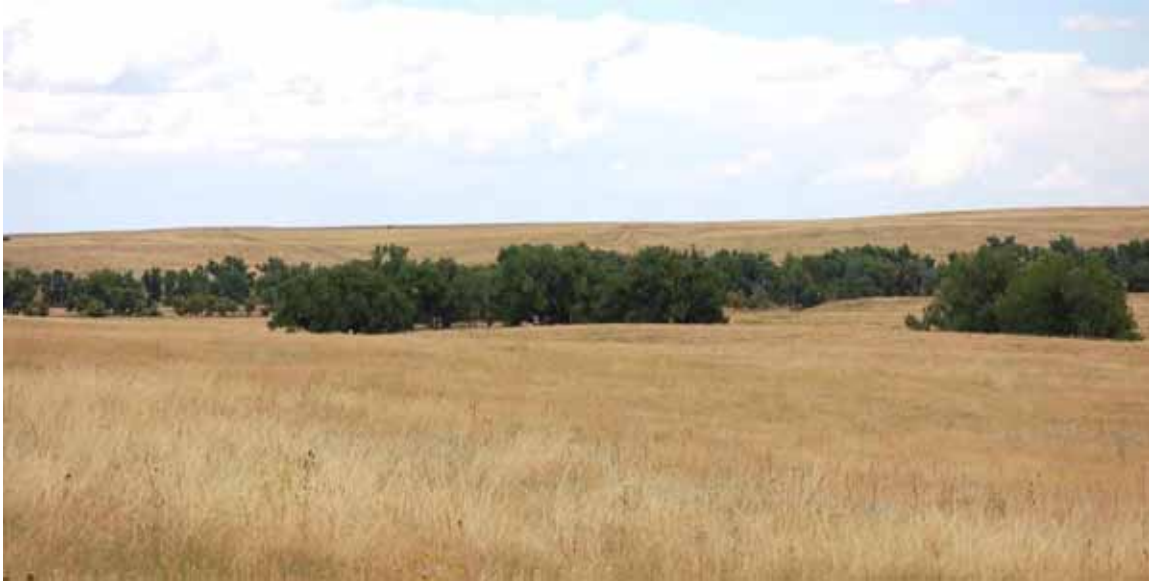
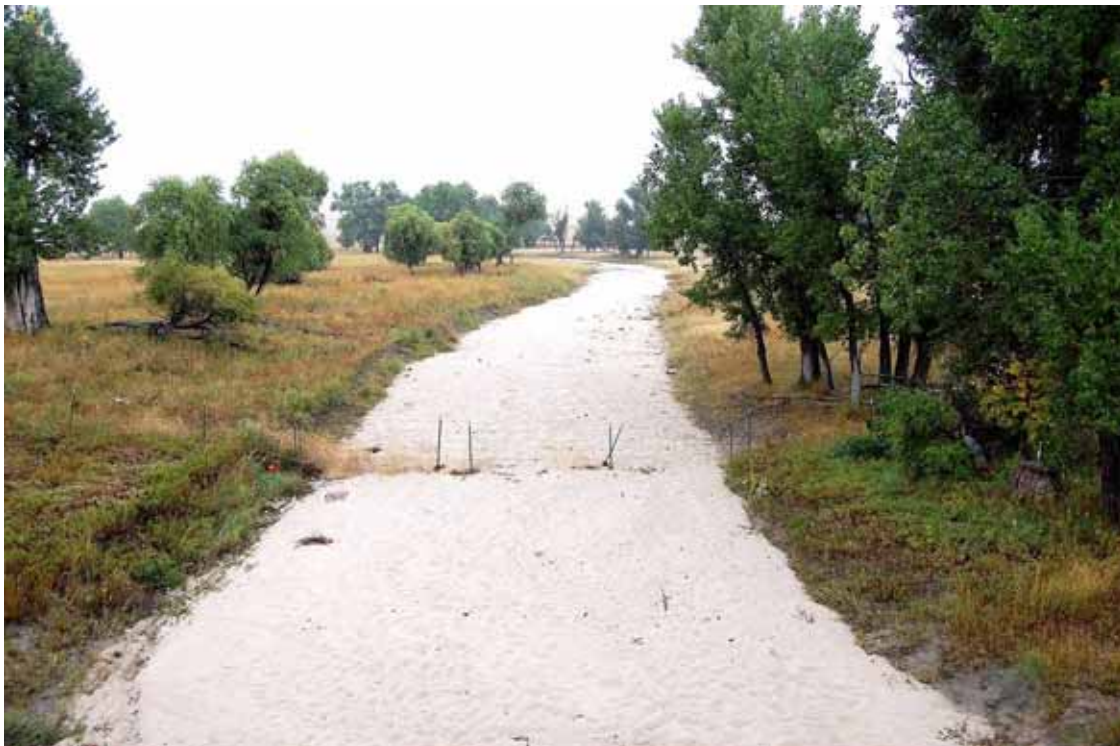
Below is a photo of the junction of the Black Shack drainage and Coal Creek. The second photo is of Coal Creek upstream from this junction. The riparian woody habitat along these draws is extremely important for songbirds, raptors, fox squirrels, whitetail deer, northern bobwhite quail, mourning dove, turkey, and many other species. Drainages with ephemeral flows like these two creeks are where native trees are typically found in the semi-arid plains.

The section of Coal Creek shown in the photo above is less than ½ mile upstream from the junction. It was taken shooting north from the bridge over Coal Creek that is about ¼ mile east of the bridge over Black Shack Creek. Note the bed is dry sand, which would enable the moisture from regular rain events to drain easily. However, the bed and bank are very established, and there is little or no vegetation in the channel because of scouring from high flows.

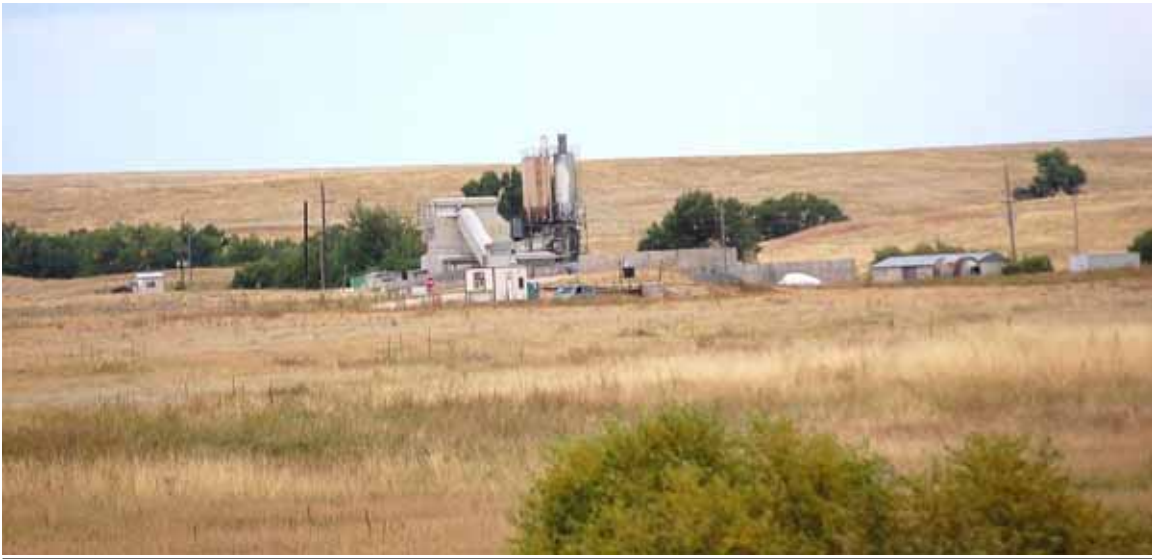
The last photo shows an industrial site (e.g., sand mining) located in the floodplain of Coal Creek drainage just ½ mile upstream from the bridge on Quincy Avenue. Furthermore, a new subdivision is being built just a couple of miles to the southwest. These important ephemeral streams are threatened by development and should be protected.
