**Showcasing ecological
engineering case studies**

*International
Office
for Water*

Title : Showcasing ecological engineering case studies

This document gathers the factsheets produced as part of a work to showcase ecological engineering case studies.

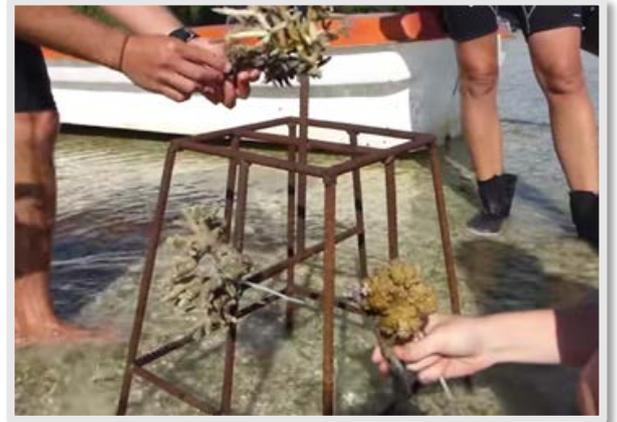
Coral cage – Vanuatu (©Island Reach)

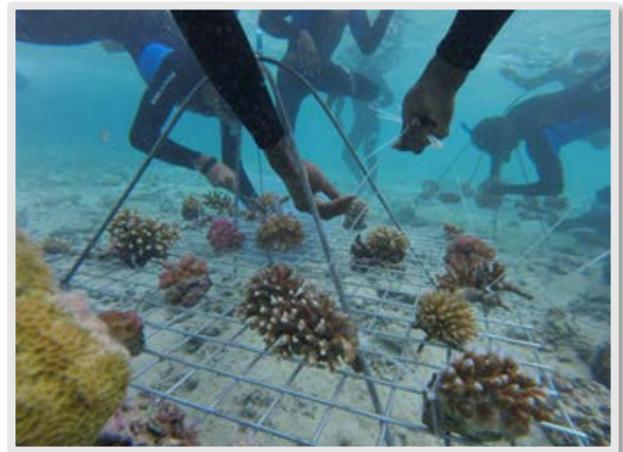
*Coral gardening on galvanised mesh wires – Vanuatu
(©CCCP-IR-SPC/GIZ)*

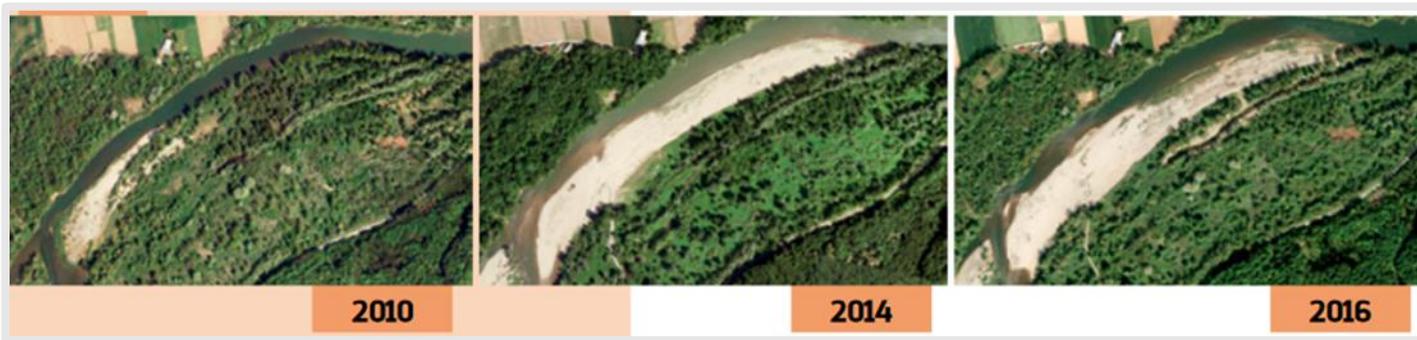
Work on the river bank and aerial photos before and after restoration (Source: LiveDrava layman's report, 2018)

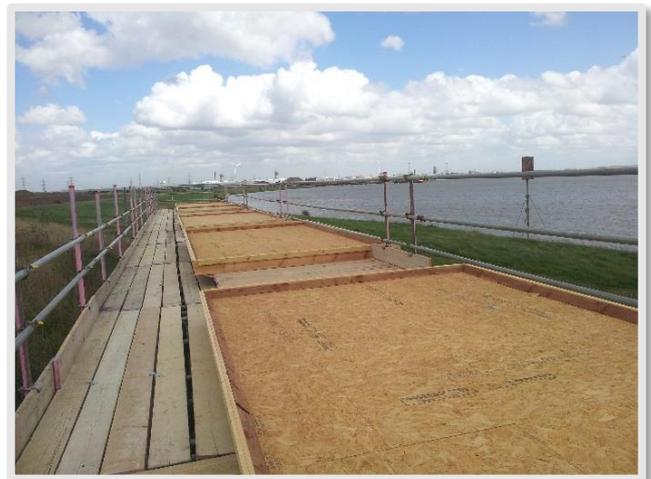
Wooden frames constructed as a base for the ephemeral wetland green roof experiment - Barking Riverside, London, UK. (©UEL SRI)

Nine used 20 foot freight containers were purchased as the base for the experiment. The frames for the green roof test beds were constructed out of timber. Freight containers were used as a practical solution in the absence of suitable built structures. Whilst these provided only a single storey level, their position on site, close to the river corridor, meant that they were very exposed and, thus, environmental conditions on the roof would have been similar to those experienced at higher roof levels in other locations. As such, habitat development would be expected to be typical of building roof conditions. Previous studies have demonstrated that height of roof may lead to limitation for accessibility for some groups/species. However, this is a graded response in relation to height and species/groups, so further experimentation would be required to investigate any effect in relation to colonisation of ephemeral wetland roofs.

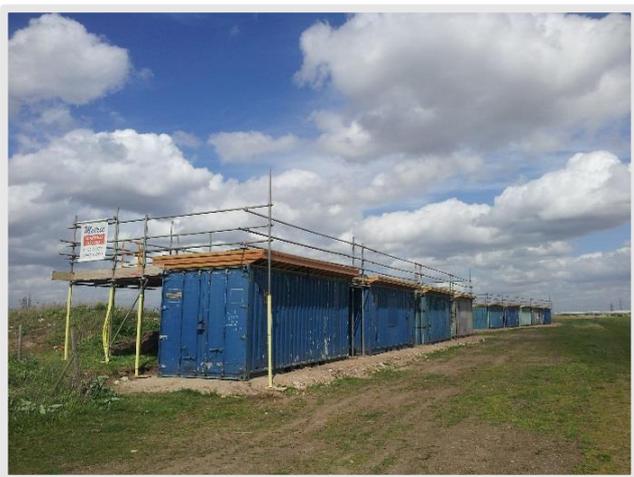
Freight containers with ephemeral wetland green roofs on top in place for experimental monitoring - Barking Riverside, London, UK. (©UEL SRI)

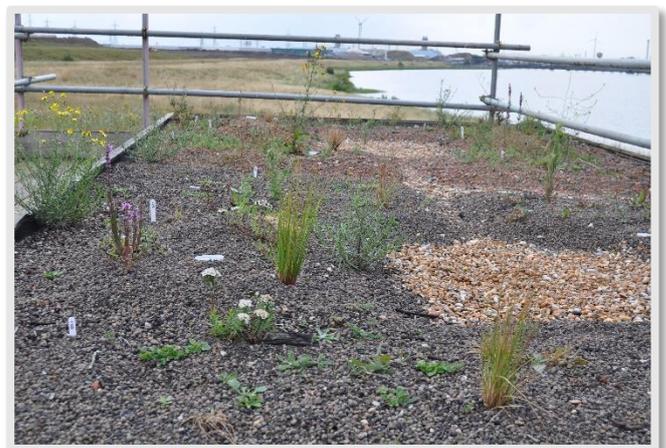
Toits verts à zone humide éphémère une fois les plantes installées, Barking Riverside, London, UK. (©UEL SRI)

The test platforms were built according to small green roof construction best practice and following principles for biodiverse green roof design (e.g. using varied substrate types and depths and planting with native species). The roofs were seeded with a combination of three 100% wildflower seed mixes supplied by Emorsgate Seeds (www.wildseed.co.uk) as follows: EM8F wildflowers for wetlands; EN1F special pollen and nectar wildflowers; ER1F wildflowers for green roofs. This mix was then broadcast at a rate of 2 g/m².

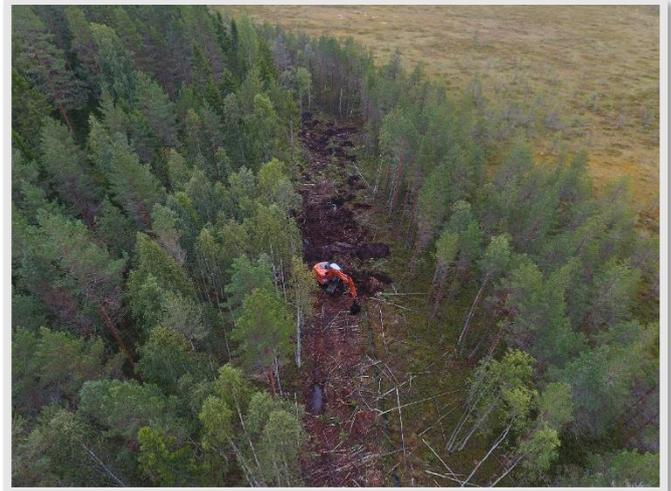
Excavator filling in the drainage ditch in forest-covered mire in North Karelia 2017 © Metsähallitus/M.SIMILA

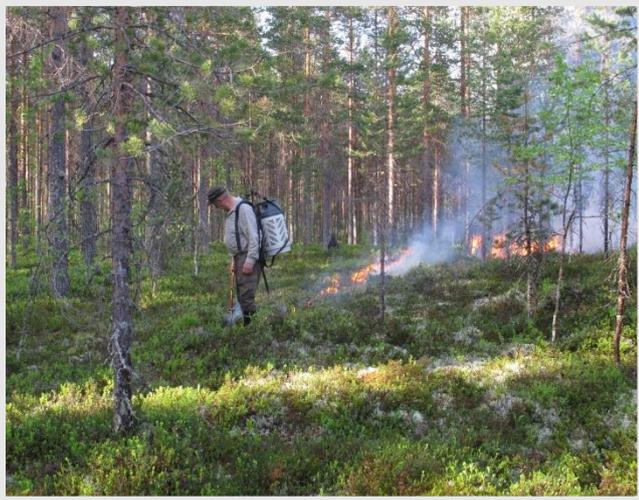
Liquefied petroleum gas is used to set the fire. © M.SIMILA

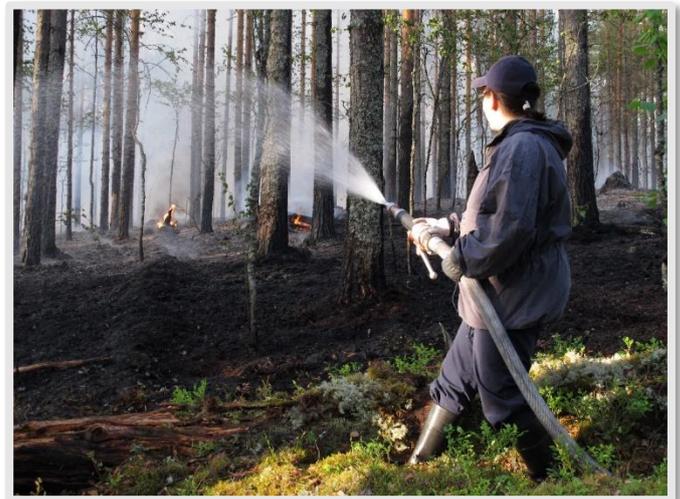
After the burning the edges of the burnt areas are watered carefully. © M.SIMILA

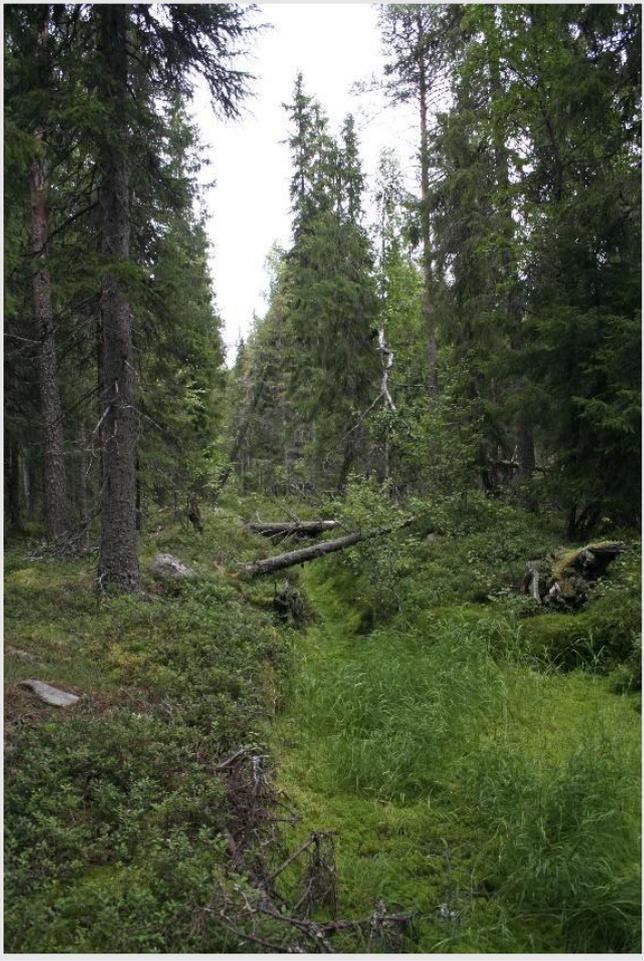
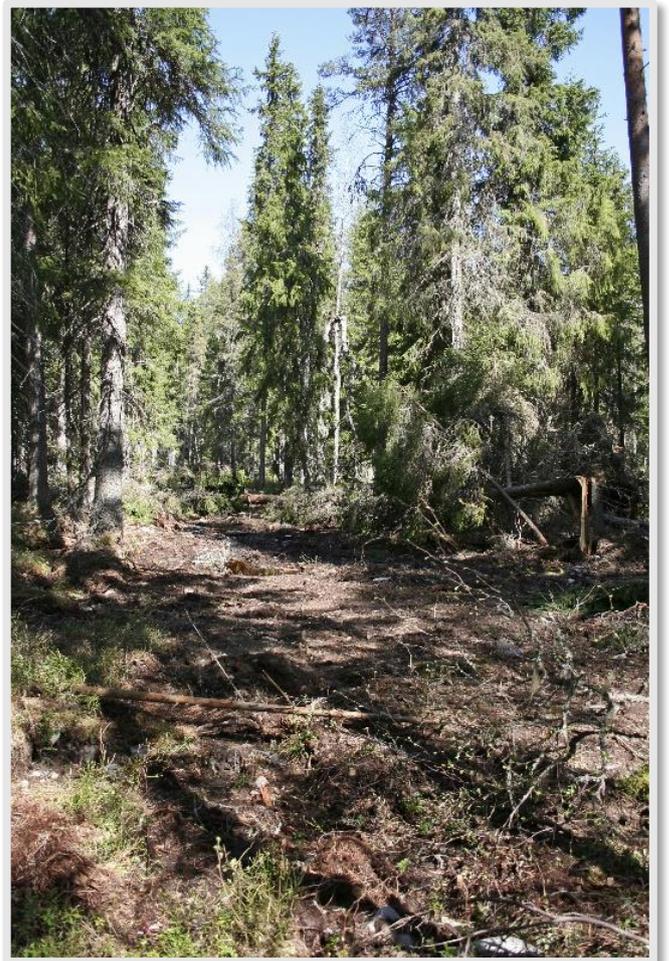
Finnish spruce-dominated mire before and after restoration. © M.SIMILA

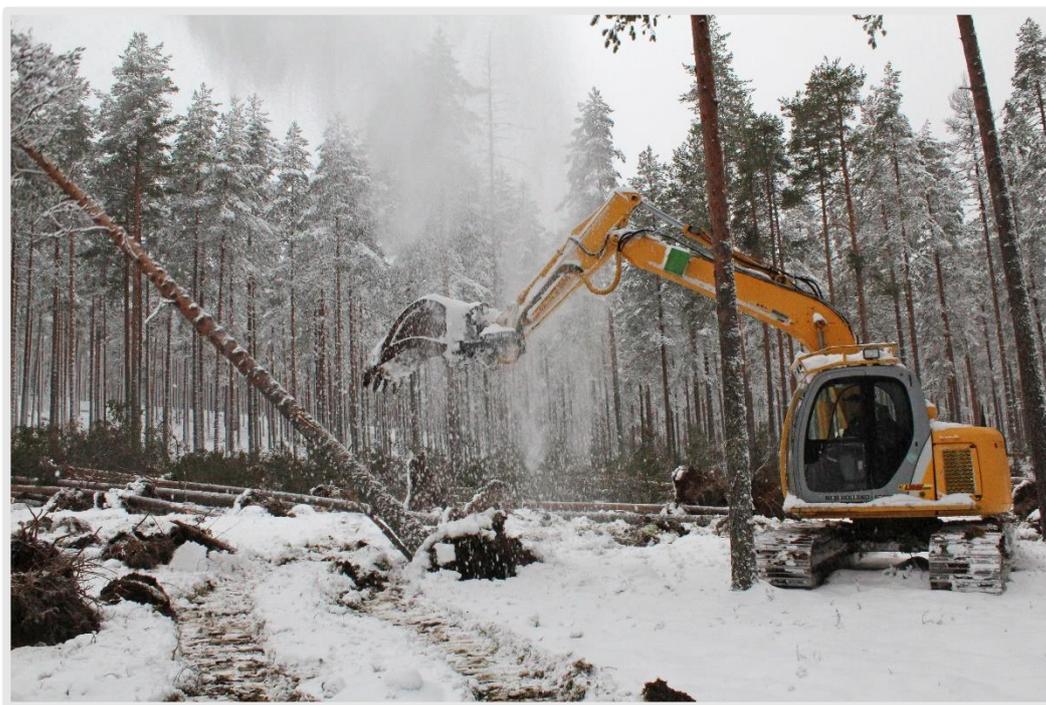
Finnish spruce-dominated mire before and after restoration. © M.SIMILA

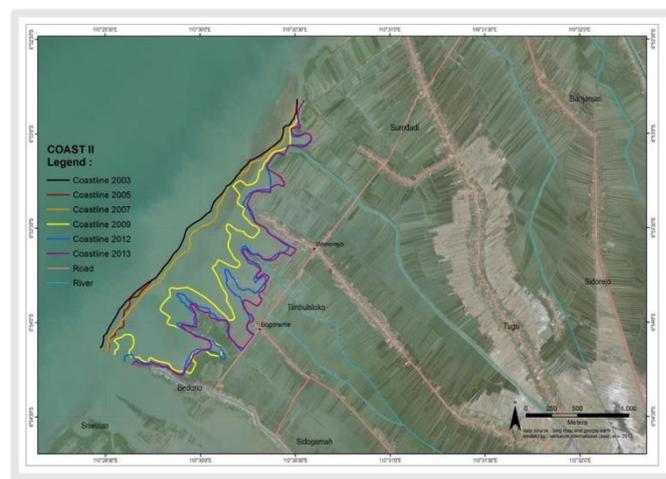
Demak from outer space and evolution of the coastline © Wetlands International

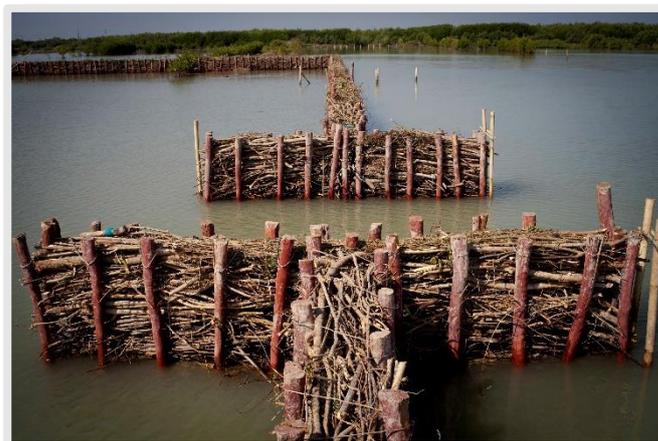
Permeable structures © Nanang Sujana

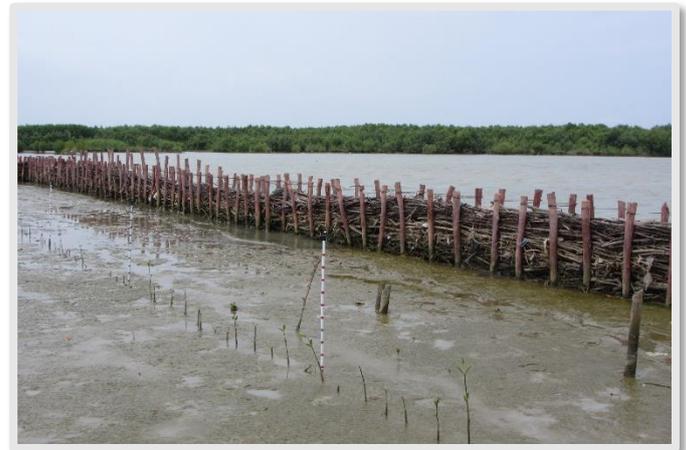
Sediment accumulating inside the permeable dams © TONNEJICK F.

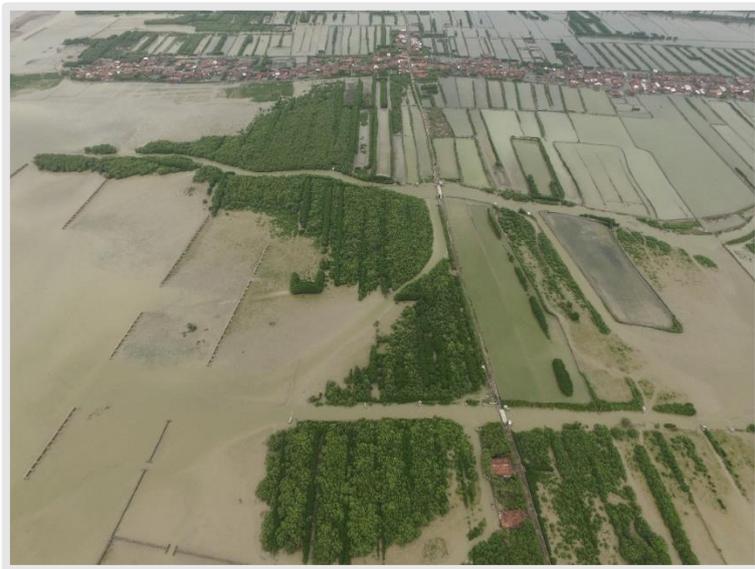
Mangrove recovery behind permeable dams © PT. Prospek Empat Dimensi

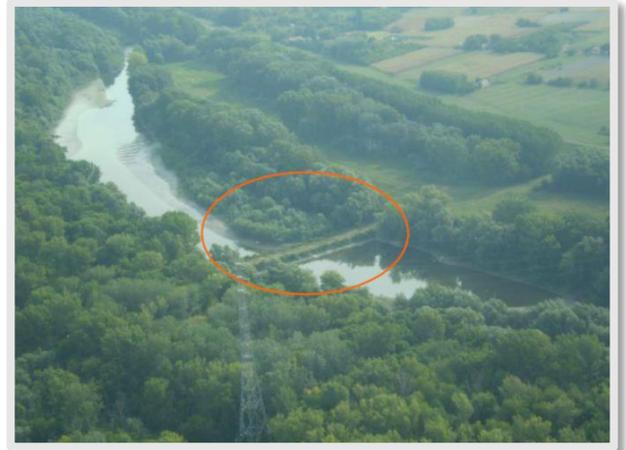
The rock-fill dam – Source: WWF

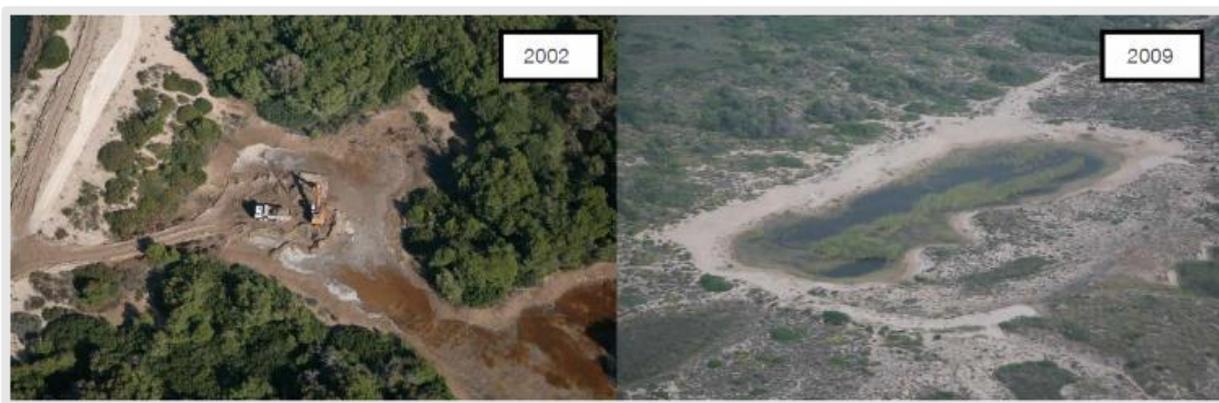
2002: Malladeta north and Brava beaches. Mallada de la Mata del Fang. Extracting sand and creating lagoon with permanent water, during the LIFE DUNA project.

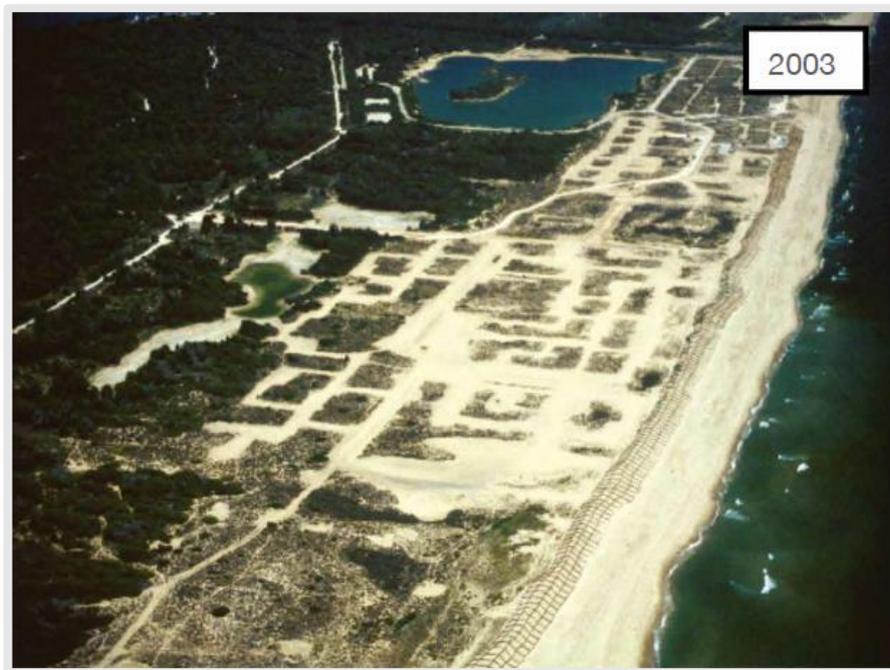
2003: During the LIFE DUNA project: Malladeta north and Brava beaches. The boardwalk has been removed and replaced by a dune system/cord. This has been set back 5m inland with respect to the boardwalk. The roads and car parks have been eliminated.

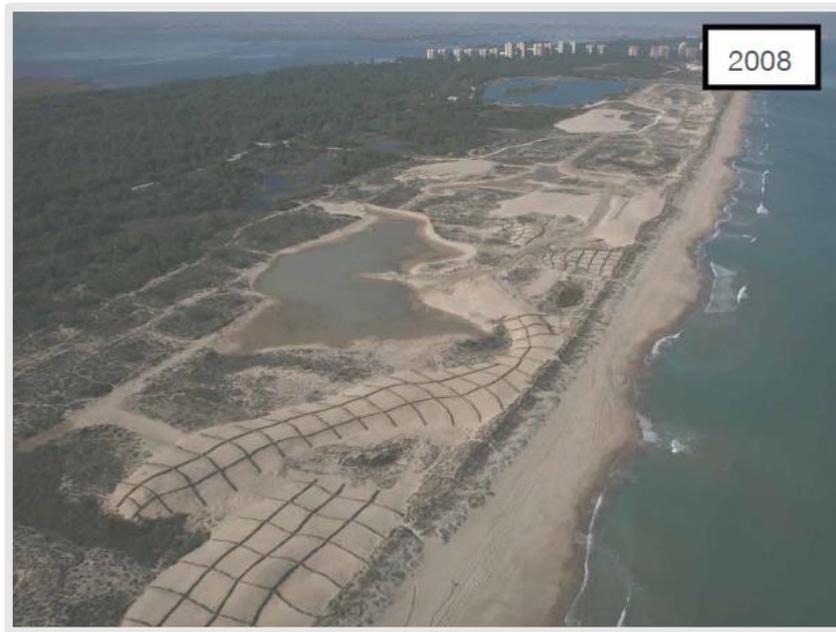
2008. During the LIFE ENEBRO project: North Malladeta and Brava beaches. The dunes with palisades stand out, recently repopulated with vegetation, and the craters from which part of the sand has been extracted. The first front dune is completely restored.

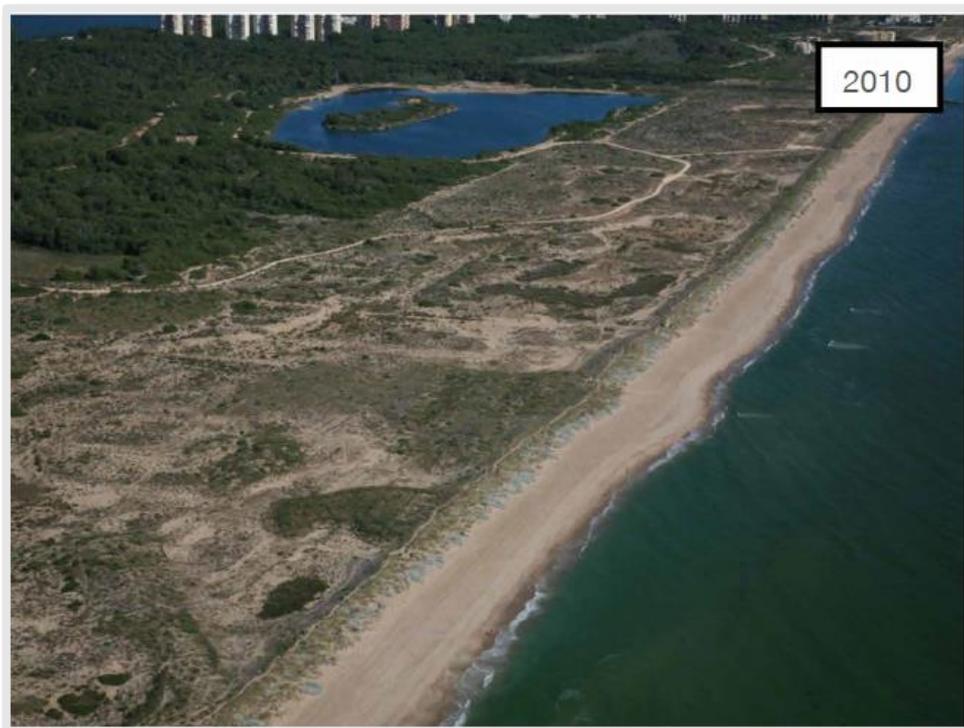
2010 : North Malladeta and Brava beaches. The restoration is finished. The first front dune was executed during the LIFE DUNA project and the transition zone during the LIFE ENEBRO project.
